ENVIRONMENTAL ASSESSMENT

Jamaica North South Highway - Caymanas to Linstead Realignment

JAMAICA NORTH SOUTH HIGHWAY – CAYMANAS TO LINSTAD REALIGNMENT

Submitted to:
**NATIONAL ROAD OPERATING AND CONSTRUCTION
COMPANY**

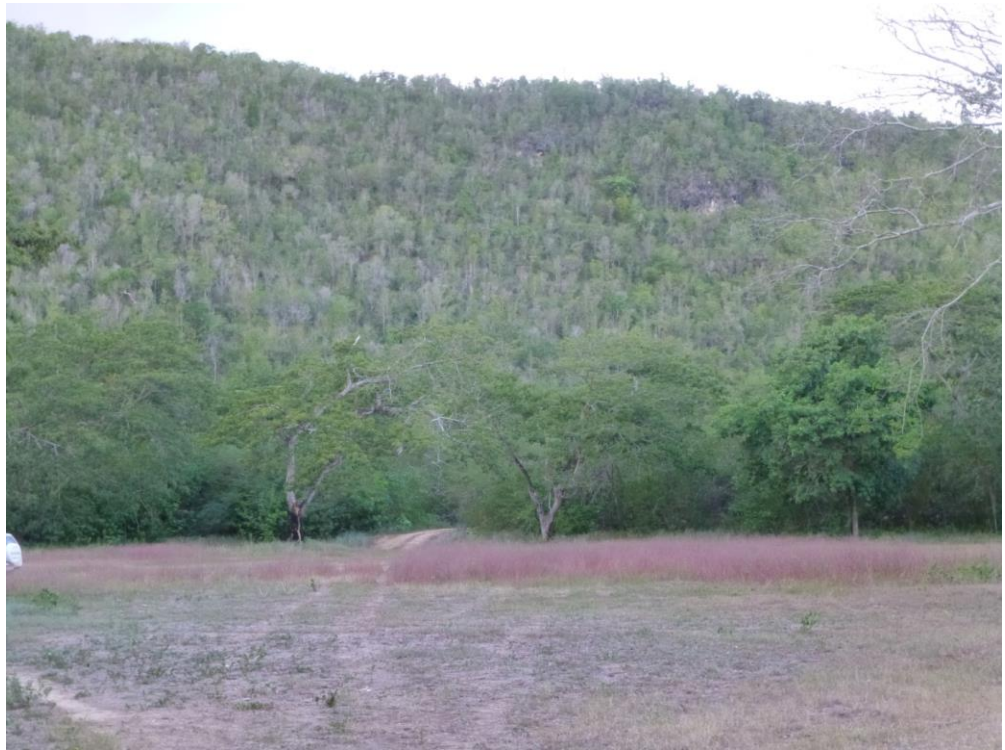
Plate 1 Caymanas Fault Escarpment

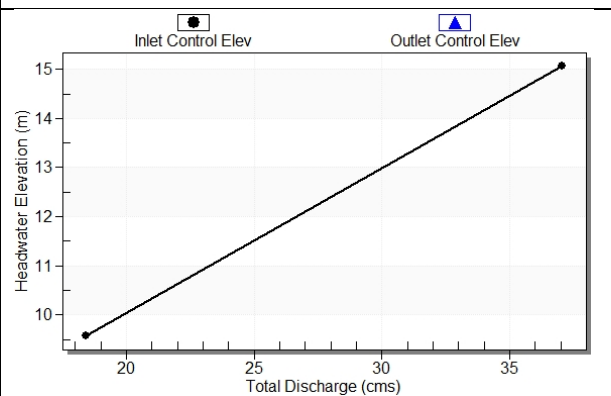
Figure 26 Performance curve for culvert during 1:100yr rainfall event using one (1) 2.5m culvert pipe.

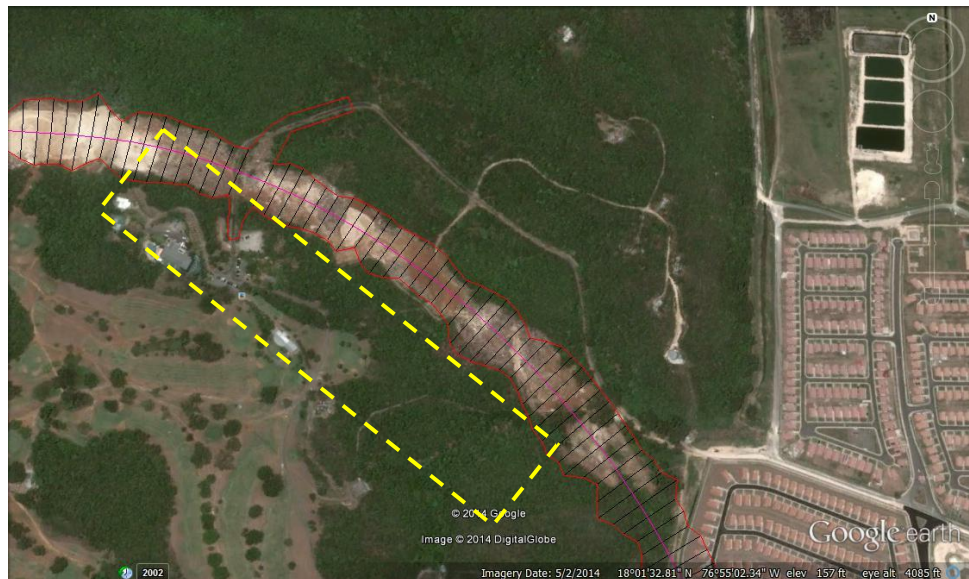
Based on the variability in topography the study site was divided into three zones. The first proceeded 0.76 km down-slope Mount Gotham, roughly south-east from the CGCC to the CCCE housing development (Figure 56). This was an active construction zone where the rights-of-way were already cleared and an approximate 100 m swath of exposed limestone (both pulverised and unprocessed) was observed. The vegetation within was limited to a smattering of relict and regenerating tree species as well as secondary pioneer herbs and shrubs.

Figure 56 Zone 1, as approximated by the dashed, yellow boundary. Note the cleared area within the red-boundary lines which represent the 100 m wide rights-of-way.

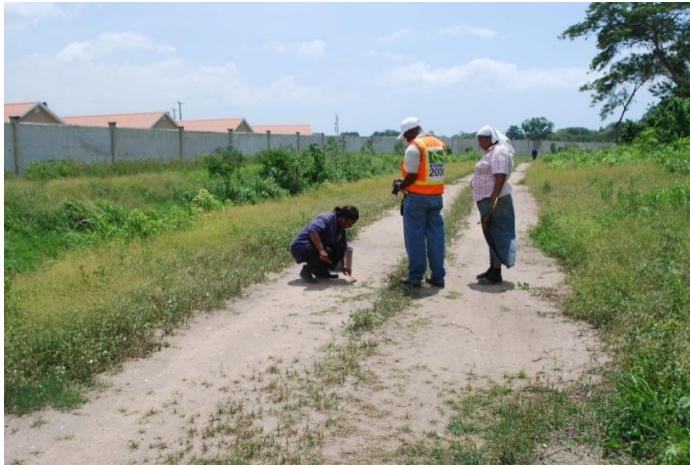
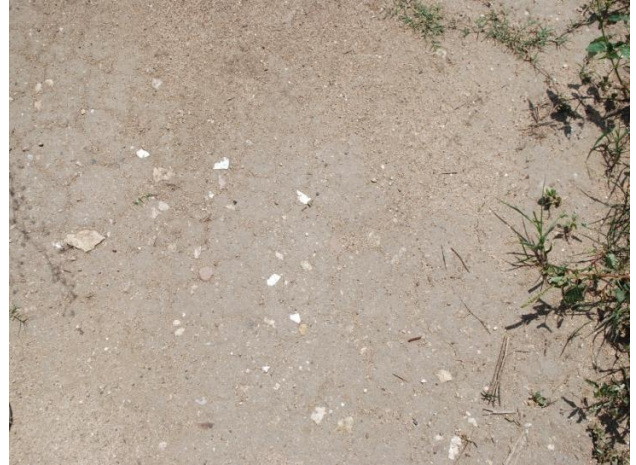
Plate 8 Assemblage of artefacts in the roadway in the vicinity of the Slave Village

An assemblage of artefacts was found along the roadway (Plate 8 and Plate 9) and in the vicinity of the Slave Village.

Some Spanish rubble along with pieces of Taino sherds and pieces of ceramic sherds were found in the vicinity of Grid reference 18Q 0297252, 1993816 in the area just to the west of the Old Ellis Works.
